# AM/NS Ports

**Subject:** Submission of Half Yearly Compliance Report for the EC & CRZ Clearance granted for “*Expansion of Port Facilities at Hazira, Gujarat*”. Compliance Period – October 2025 to March 2026 for year 2025-26.

# Final Report for Mangrove Mapping Using Satellite Imagery

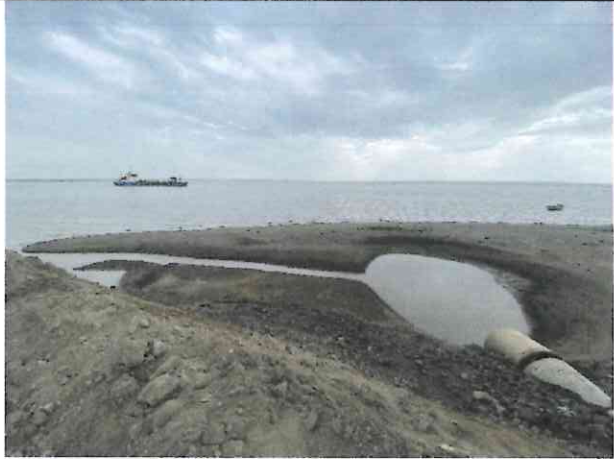
<p style="text-align: center;">Hume Pipe</p>
iv)	Project proponent shall submit once in 12 months the latest satellite imagery to MoEF to ensure that mangroves are remains fully intact. Any shrinkage in mangrove area noticed either in satellite imaginary or during site visit, shall be taken as violation.	Noted and being complied on Regular Basis. Mapping report carried out by Gujarat Institute of Desert Ecology (GUIDE) for year 2024-25. The report is attached as Annexure 1 along with this report.

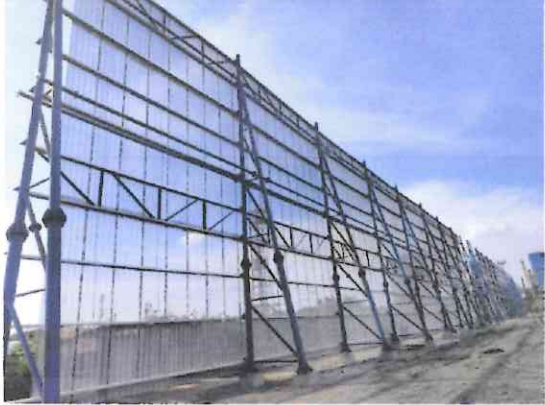
<p style="text-align: center;">Fully Developed Wind Fence</p>
viii)	The height of coal stack yard shall be at least 2 feet below the height of wind curtain.	<p>Complied.</p> <p>It is ensured that the height of stacks remains 2ft below the wind fence.</p>
ix)	Greenbelt shall be provided all along stack yard and in the premises.	<p>Complied.</p> <p>A 10 m thick greenbelt with 3-rows plantation has been developed all along the boundary of the port and stack yard. Greenbelt development is a continuous process in port.</p>

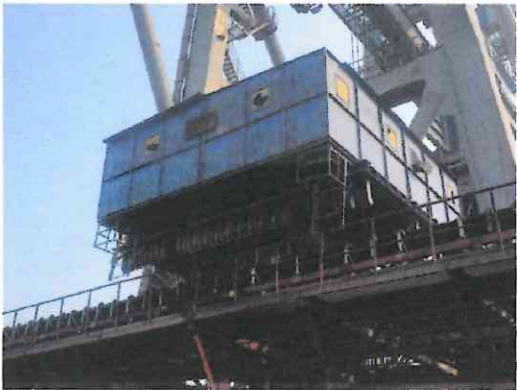
<p style="text-align: center;">Canopy provided at the transfer junction</p>

x)	The existing coal conveyor from berth to stock yard shall be closed with cover since the present water spray appears to be inadequate.	<p>Noted and complied.</p> <p>Bulk material is being handled by means of closed conveyor system only. Transfer junctions are also provided with closed canopy to reduce the fugitive dust generation right from the source.</p>

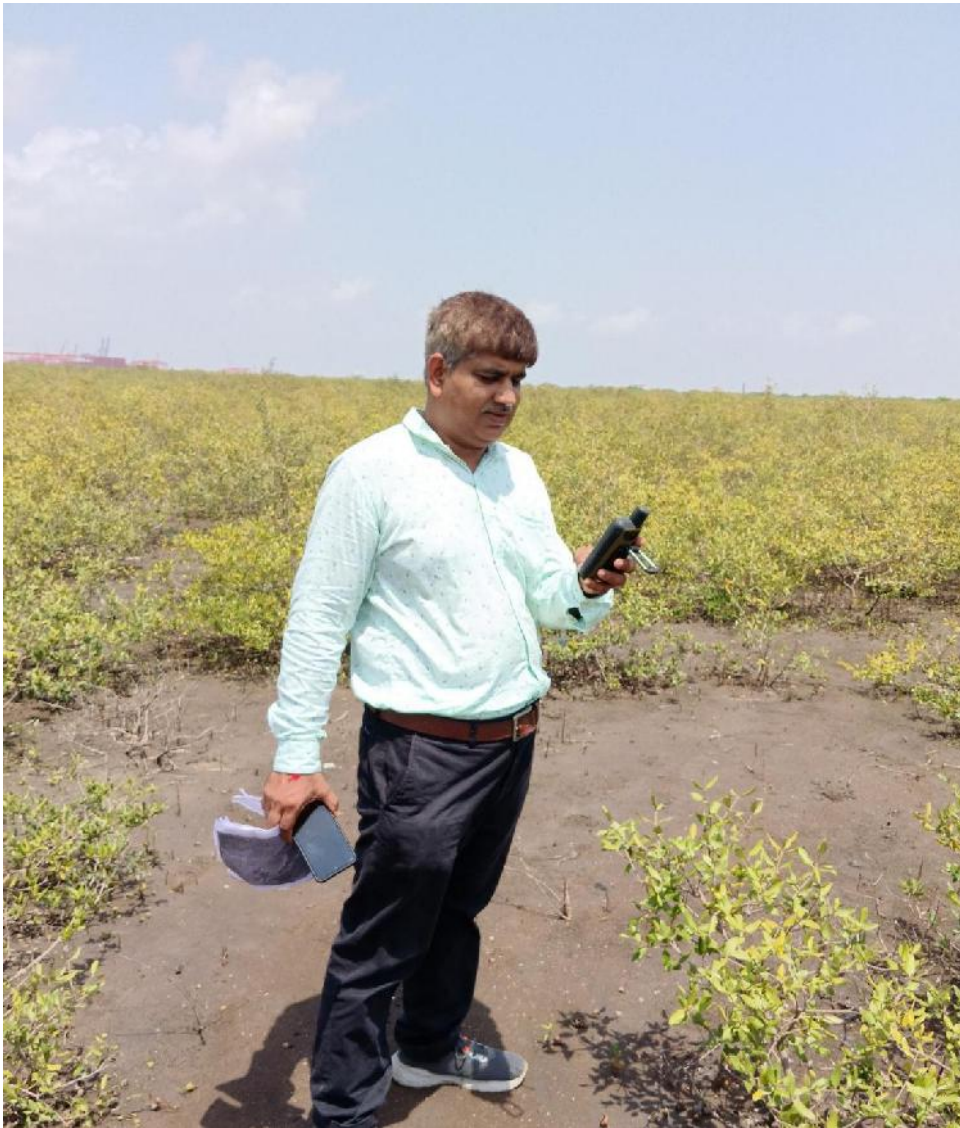
**Figure 3.1: Ground Truthing Data Collection in the Field by GPS.**

The features identified in the field were then correlated with image elements, allowing for accurate interpretation and classification. Furthermore, GPS observations collected from different quadrats across the site were documented, and these spatial data points were later superimposed on the satellite imagery to strengthen the mapping accuracy (Figure 3.2). This integrated approach of field survey, ground-truthing, and geospatial analysis ensured a reliable representation of the land cover and mangrove distribution within the study area.

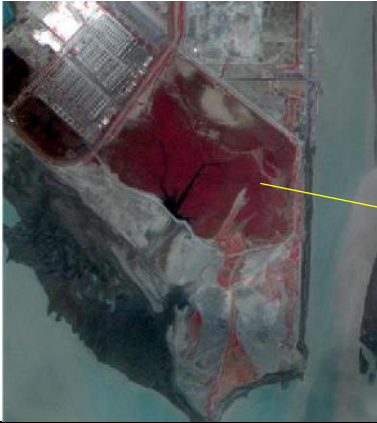
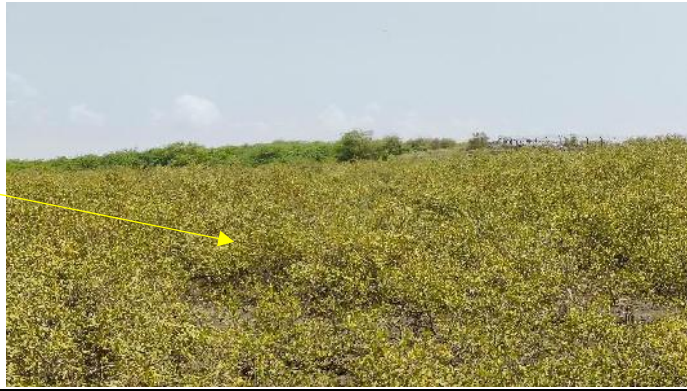
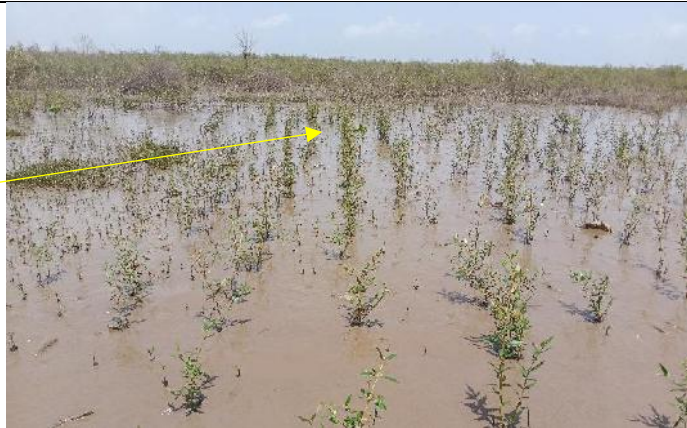
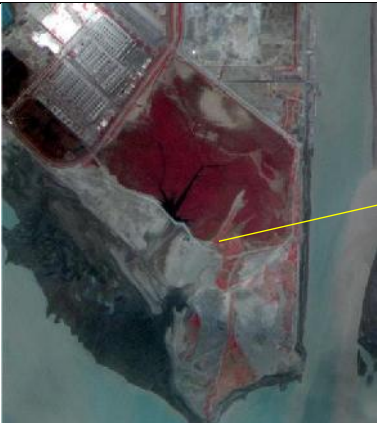
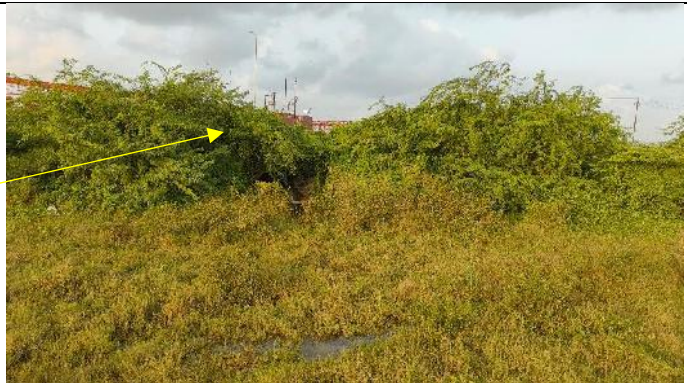
Figure 3.2: Various Land-Cover Classes in The Study Area.

Dense Mangrove

Mangrove Recruitment and Regeneration

Other Vegetation

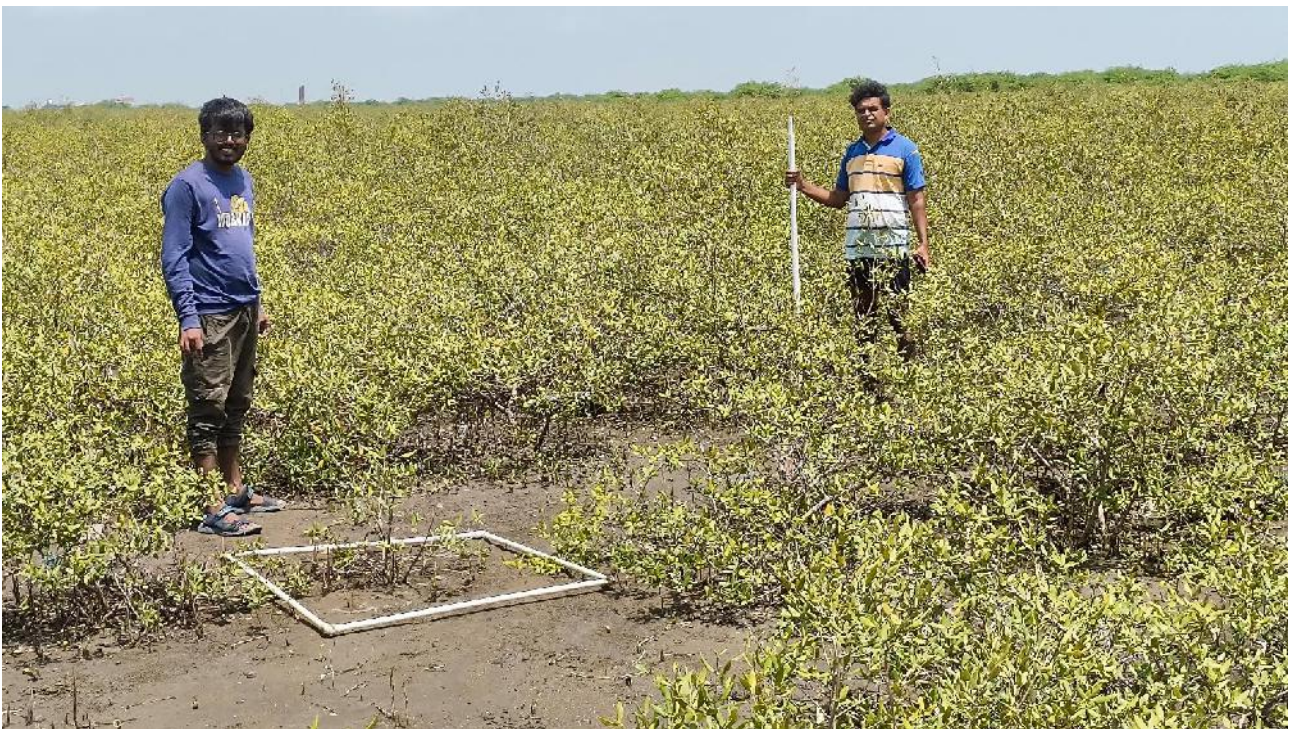
**Figure 3.3: Mangrove Data Collection**

In total, 10 random samplings were carried out in the mangrove formations of the APHL Hazira at different landscapes like mangrove and regeneration and recruitment patches (Figure 3.3).

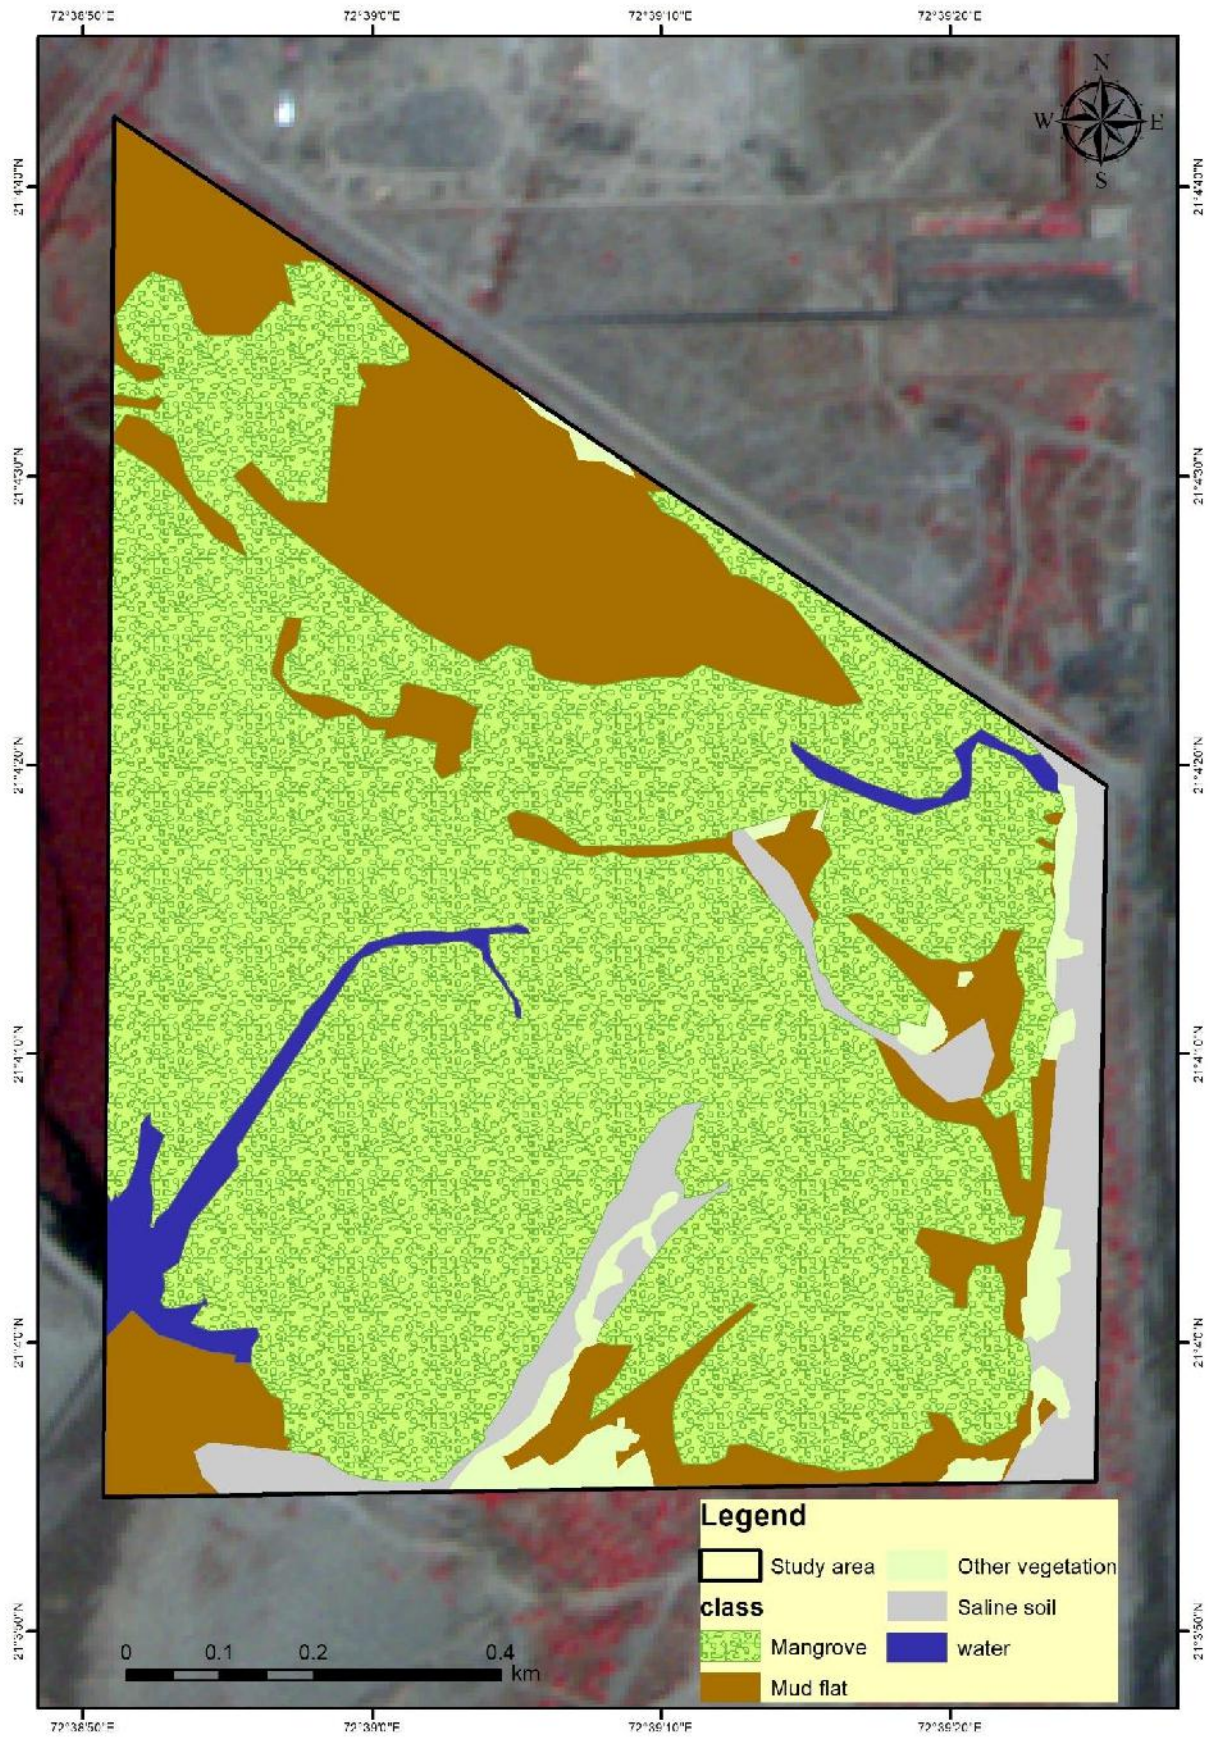
**Figure 4.1: Land Cover Classification Map of the Study Area -April 2024**

No.	LULC Class Name	Area (ha)	Percentage
1	Mangrove	73.83	67.05
2	Mud flat	23.54	21.37
3	Other vegetation	3.09	2.81
4	Saline soil	6.87	6.24
5	Water	2.79	2.53
Total		110.11	100.00

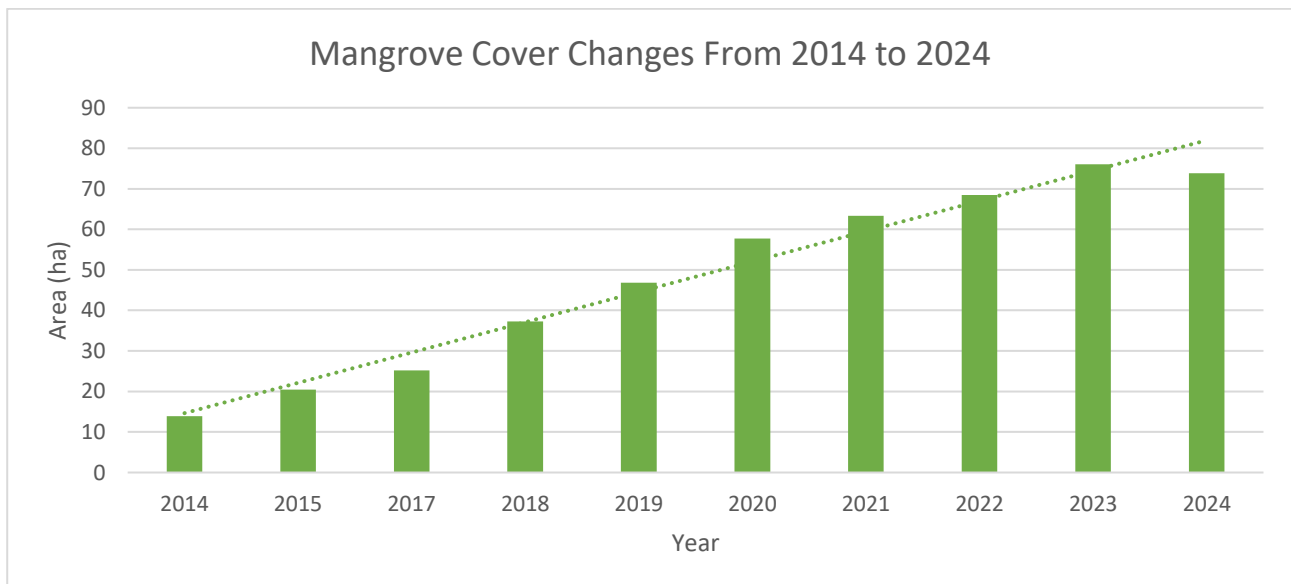
**Figure 4.3: Mangrove Cover at APHL, Surat from 2014-2024**

Overall Mangrove cover showed a minimal decrease in the study area, which is due to the degraded patch of regeneration and the recruitment category of plants. A decrease was observed predominantly along the northern sector, while the southwest sector exhibited mixed trends along the mouth of the inlet creek (Figure 4.4), with a decrease

S. No	Year	Mangrove Cover (ha)	Yearly Increase in Mangrove cover (ha)	% Increase (Compared to Previous Year)
1	2014	13.89	0	0
2	2015	20.45	6.56	47.2
3	2017	25.18	4.73	23.1
4	2018	37.26	12.08	47.9
5	2019	46.86	11.6	31.1
6	2020	57.73	8.87	18.9
7	2021	63.30	5.57	9.6
8	2022	68.50	5.2	8.2
9	2023	76.08	7.58	6.7
10	2024	73.83	-2.25	-2.0

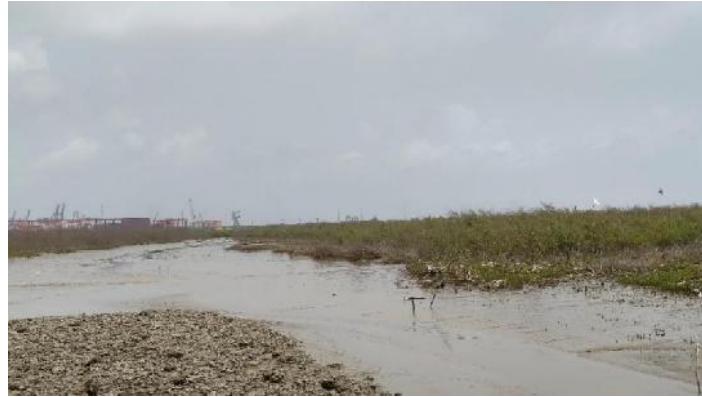
anthropogenic activities in this area. During the high tide, these materials may reach inside the mangroves and get trapped in this area.

**Figure 4.11: Non-Biodegradable Debris at the Mangrove Areas**

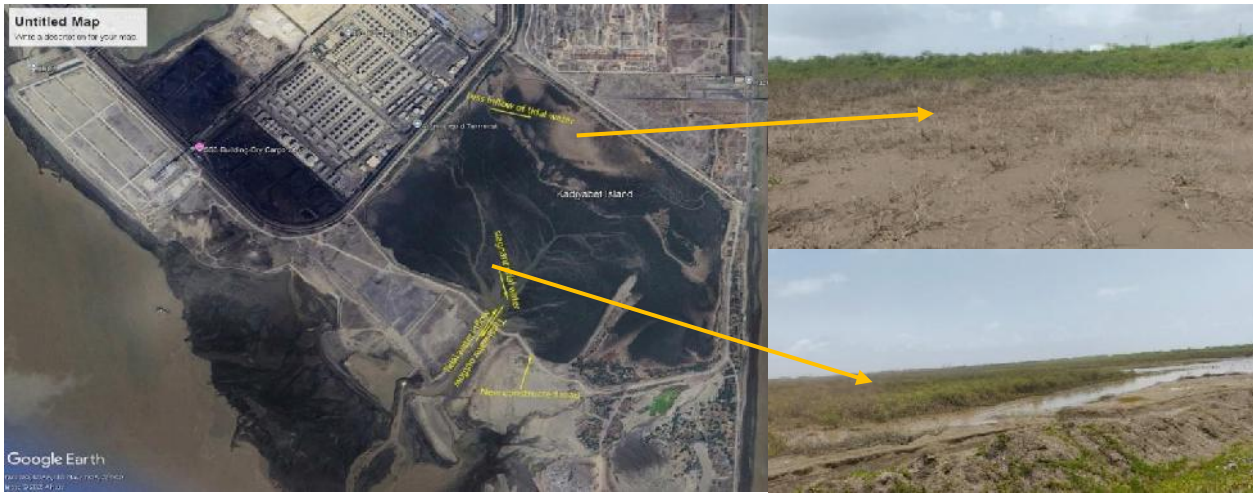
In the present study, signs of dieback and drying of mangroves especially in the recruitment and regeneration classes were observed in few patches of the mangrove habitat, indicating ecological stress and instability. Notably, two distinct zones of degradation were identified, *i.e.*, one toward the seaward side (southwest direction) and another toward the landward side (northern direction) due to a road traversing the study area.

**Figure 5.1: Mangrove Degradation Due to New Constructed Road**

The obstruction caused by the road and its allied conduit or culvert for tidal water flow has likely to be impeded the free tidal flushing, a vital process for maintaining the health of mangroves. On the seaward side (southwest direction), it aids waterlogging due to poor outward drainage and prolonged inundation beyond the tolerance limits of mangrove species results in reduced soil aeration, limiting oxygen availability for root respiration and nutrient uptake. These conditions degraded the root systems and alter microbial activity, compounding the stress and increasing mortality risk. While, along the landward side (northern direction), mangroves exhibit signs of desiccation and salinity build-up, due to restricted tidal flushing caused by the same road which led to deprived water flow and reduction in maintaining the essential soil moisture and subsequent nutrient replenishment. This has impacted the regeneration and recruitment classes of mangroves and enhance the growth and proliferation of saline tolerant halophytic species such as *Sesuvium* sp. and *Salicornia* sp. Their increased presence in the affected zones further suggests a shift from mudflats to salt marsh vegetation, driven by altered tidal dynamics. Thus, the cause of mangrove degradation

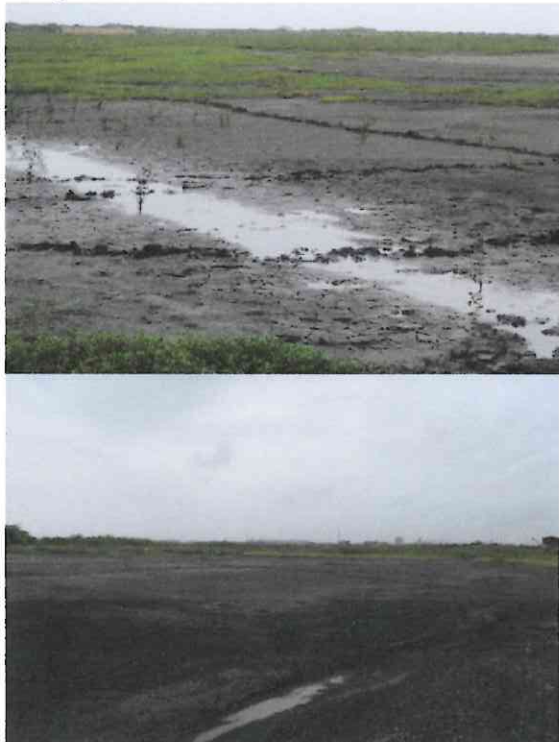
S.No.	Condition	Compliance Status
1	The provisions of the CRZ Notification of 2011 shall be strictly adhered to by M/s. EBTL. No activity in contradiction to the provisions of the CRZ notification shall be carried out by M/s EBTL.	Noted and Complying.
2	Natural drainage system shall be designed in such a way that there shall be no damage to the existing mangrove patches nearby site.	<p>Complied.</p> <p>The existing mangrove patch is undisturbed. Natural flushing takes place and Hume Pipes are additionally provided.</p> <p><i>Mangrove Area</i></p>

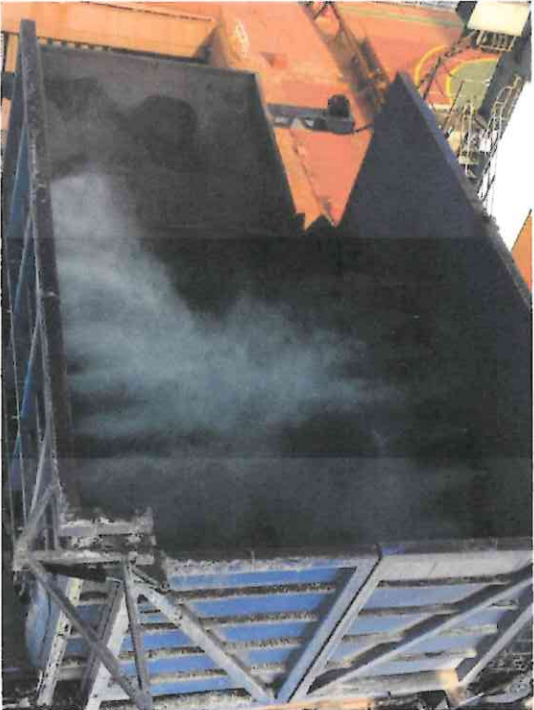
S.No.	Condition	Compliance Status
		<p>talukas, District Bharuch, Gujarat which is now in maintenance phase.</p> <p>In addition to these, Plantation work carried out by M/s. SARVA Services in October 2022 for 50-ha mangrove plantation in intertidal mudflat area of village Nada, taluka Jambusar of Bharuch District. Reports are being submitted along with the EC compliance reports of the corresponding years. Currently, we have plan to plant mangroves about 100 Ha.</p>
4	<p>Coal, ore and other material handling shall be done through totally closed system.</p>	<p>Complied.</p> <p>The existing coal conveyor system is full covered. Water sprinkling system has been provided in hoppers and all the transfer points to control the fugitive dust emissions during the operations.</p> <p><i>Picture of Sprinkling System working in Unloading Point</i></p>
